CONSERVATION AND RESTORATION RESEARCH

ON 2NDBCE MURALS OF AJANTA

General condition of the cave 10

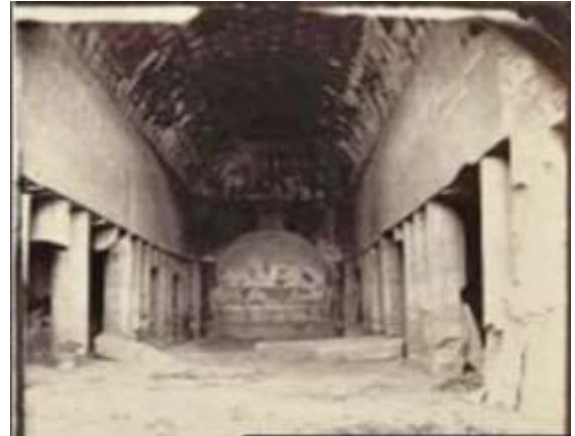
water which is supposed to flow into the ravine of Waghura River has entered inside the cave . Photograph (1A) shows the condition of the cave no 10 in 19th century when muddy water flowed inside the cave causing damage to the structure and paintings up to 4-5 feet from the floor level of the cave . In the long run this has also caused crumbling and falling of pillars , wooden rafters etc. into the cave interior . Major structural conservation measures were taken in the form of removing the filth from the cave interior and making new support pillars as per requirements , photo (1B) .

Photo 1A- Showing Cave no 10 in 19th Century .

Photo 1B- Showing Cave no 10 at Present .

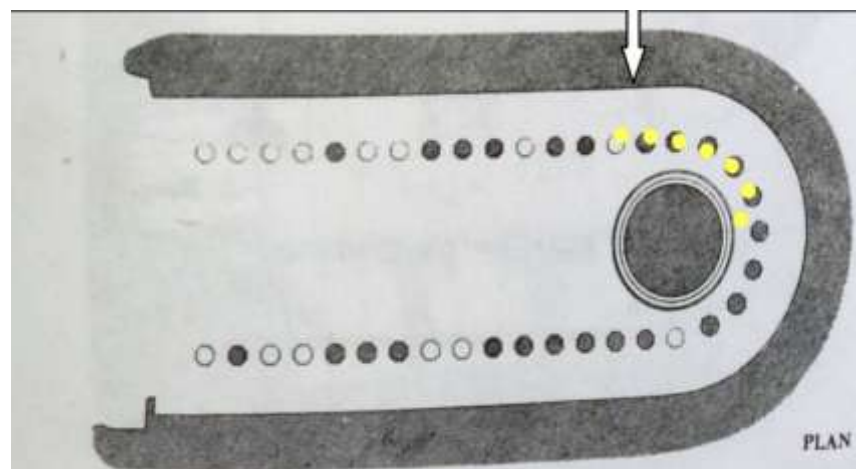
Fig.2

As the cave no 10 has the largest opening at Ajanta , wire mesh in wooden frame were fitted so as not to allow any bats / birds to enter inside the cave . A few square meters of painting belonging to 2nd BCE that survived on both side walls of cave no 10 , were also damaged by visitors graffiti . To save the paintings from graffiti , it was caged under glass on both the side wall . However , 3-4 sq.mt. 2nd BCE painting surviving on the left side wall by the side of the stupa above 8 feet from the floor of the cave were left as such without any cover . As the painting work were executed by the side of the stupa behind the pillars , the place is always dark compared to front portion and on this part of the paintings much bat excreta are noticed . Atmospheric condition of the cave has dried the excreta into a compact mass within the painted surface . Figure- 2 shows the plan of the cave no . 10 Ajanta with area marked where conservation treatment was carried out .

PLAN **Figure- 2** showing ground plan ofcave no 10 , Ajanta outlines of the painted surface As this part of the paintings were repeatedly applied with varnish coating for copying under the light of oil lamp

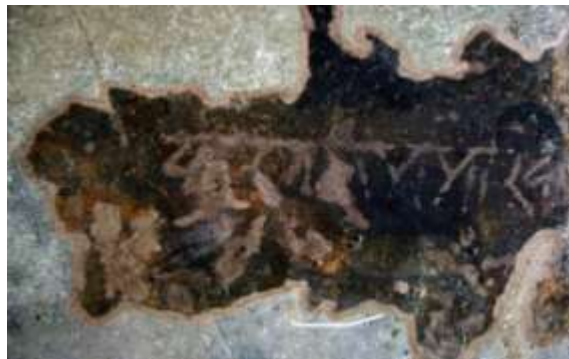
Fig. 3

the whole painted figure were totally covered under varnish layers accompanied with dirt , dust , smoke etc. Large expanses of bats dropping have made the painted surface further illegible by naked eye . Before undertaking any cleaning operation , The panel painting was observed under an adjustable illuminated magnifier . The paintings were observed by this process though the thick layer of varnishes . Figure - 3 shows the original condition of

painted plaster and outlines drawn after examining the painted surface.through thick varnish layer under magnifying lenses . As from the outside no figures are visible to naked eye due to thick varnish coats , the outlines helped the conservators in planning the conservation operation .
