## **REVIEW ON HIP IMPLANT IN HUMAN BODY**

Hip implants have been designed to restore hip joints when hip joint is out of order, hip replacement carried out by many other causes. Around the world every year about 800,000 total hip replacements (THR) being execute. A group of researchers have evaluate performance of several hip implant models in the path of biomechanical factors such as contact stresses, stress shielding, kinematics and fatigue to substantiate the quality of hip implants under specific loading conditions. Materials used for hip implants are titanium (Ti) alloys, cobalt chrome, Stainless Steel 316 L and Ultra - high molecular weight polyethylene etc. The main objective of this paper is to enlighten the knowledge about structure of hip joint, cause of joint trouble, and list out the effort for hip replacement technique and advance material development chronologically.

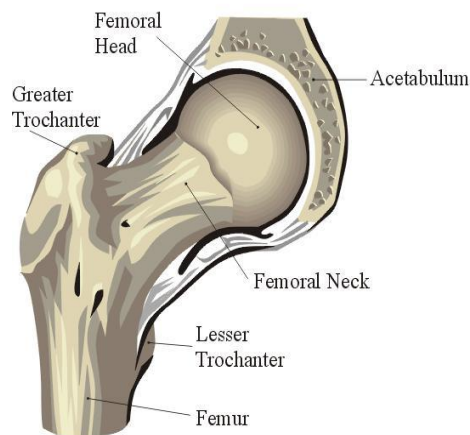
Fig. 1 Anatomy of Hip Joint.

**Hip Joint:** - A hip joint is also called as ball and socket joint, because its femoral head act as ball and its acetabulum (part of pelvic bone) behave like socket. [1] Femur is having four main divisions such as femoral head, greater trochanter, lesser trochanter, and the lower extremity shown in Fig.1. There is a smooth glassy substance lies between the joining surfaces of acetabulum and femoral head, know as cartilage. There are two femurs in human body one at right leg and another at left leg each of which carries half weight of human body [2,3].

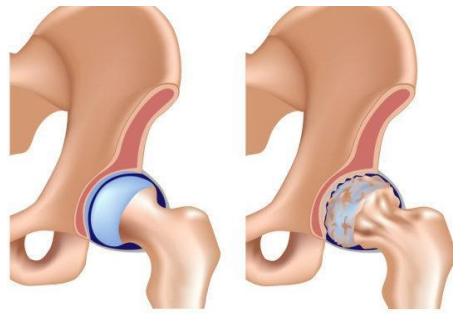
Fig. 2. Osteoarthritis of Hip Joint

**Osteoarthritis (OA):** - It is the key cause of hip collapse as well as oldest and universal type of arthritis. A Cartilage is the connective tissue that covers up the head of the thigh bone. When the cartilage being collapsed, the femoral head and the acetabulum will erode with each other, shown in Fig.2 this will source of draining of bone and bone gets deformed, even minute movement will create friction among femoral head and acetabulum of hip, compel severe pain [7].

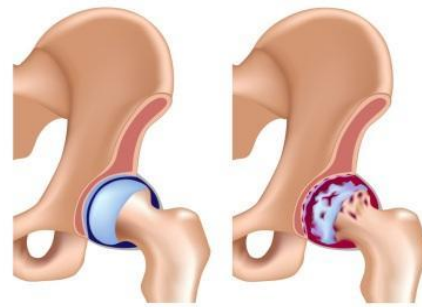
Fig.3. Rheumatoid Arthritis of Hip Joint

**Rheumatoid Arthritis (RA):** - RA is a inflammatory type of arthritis and an autoimmune disease. It may absorb multiple joints and can arise at any age. RA produce chemical changes in synovial membrane (A tissue that outline the joint and seals it into a joint capsule) that causes swells the cartilage, muscles, tendons, ligaments and also misshape (ugly shape) the joints, destroy the cartilage and ultimately lead to destruction of bone [8] shown in Fig.3.

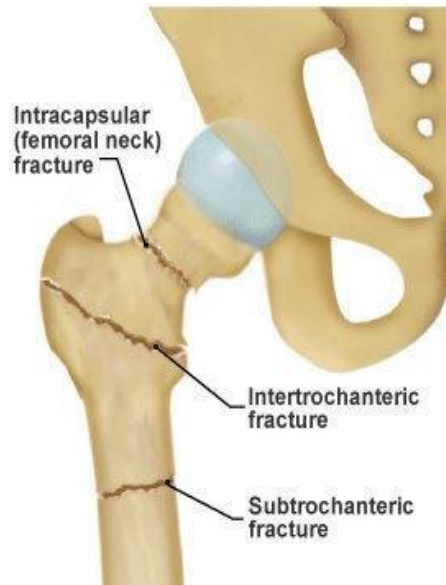
Fig.4. Different Fracture of Femur

**Femoral head fracture:** - It consists of fracturing the femoral head. This fracture often convey due to sudden energy impact and disarticulation of the hip joint.

**Femoral neck fracture:** - It consists of fracturing the femoral neck, which is in between femoral head and greater trochanter. It is a result of high energy impact shock.

**Subtrochanteric fracture:** - This fracture occurred when body of the femur (shaft) which is shortly lower the lesser trochanter is break down.

**Intertrochanteric fracture:** - This fracture takes place on the intertrochanteric line which is in between the greater and lesser trochanter. It is the universal type of hip fragmentation. If the patient is healthy then it may heal [10].

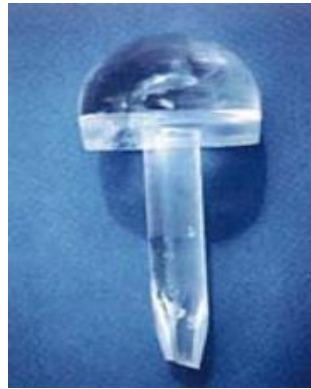
**Fig.6. Judet Brother's First Short Stemmed Prosthesis**

During 1938-1946 Dr. Robert Judet changes acute femur surface with acrylic material to provide mollify surface. Later they evolve first short stemmed hip implant (see Fig. 6) and failed due to acrylic wear debris [13].

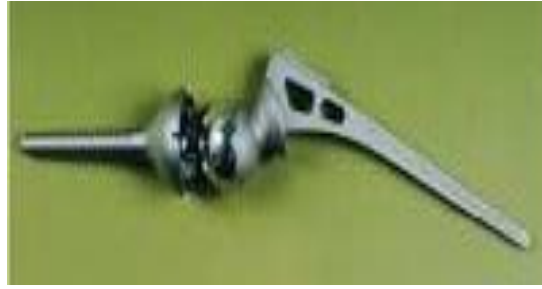
Fig.8. McKee-Farrar prosthesis

In the 1960s McKee-Farrar prosthesis (see Fig. 8) employed screw fixation but in ancient time, there was deficiency in securing technology. Thus pain was developed because of loosening of the implants [14].

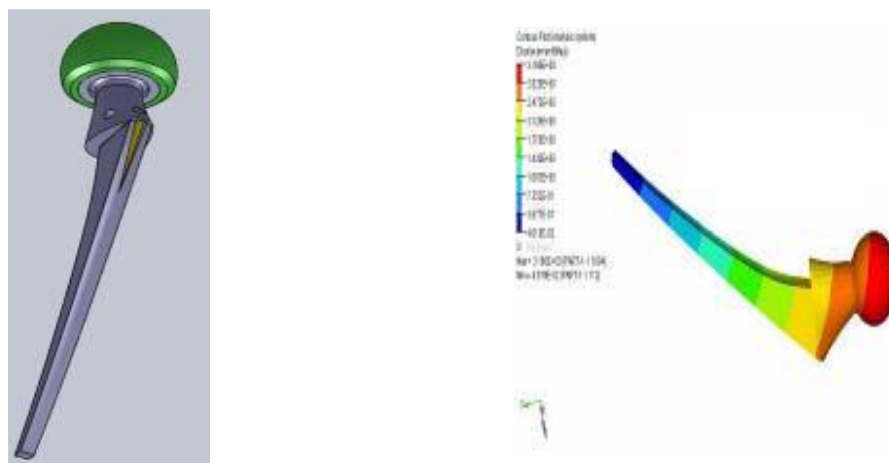
Fig.9. CAD Model & FEA Model of Bi-polar Implant

In 21st century Hanumantharaju G, et. Al prepare solid model of bi-polar hip implant (see Fig.9) of Ti-6Al-4V in solid work bench. Afterwards finite element analysis (FEA) was done using ANSYS software by apply different loading condition (250N, 500N, 1000N, 2000N) and predict the behavior of implant. After FEA it was observed that maximum value of stress is negligible, and Ti-6Al-4V alloy has high strength, superior physical and outstanding bio-compatible properties.

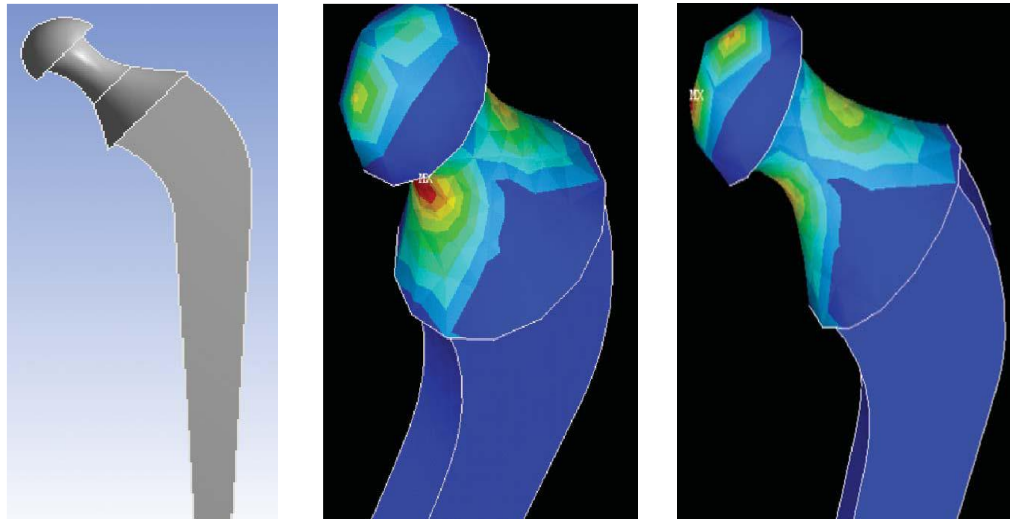
Fig.10. (A) CAD Model, (B) FEA of Standard Implant (C) FEA of Customized Implant

V. Burele et. Al deliberate Two CAD models of femoral stems of SS316L - one is made from standard hip implant available in the market while other (i.e customized implant) was designed from parameter of specific patient anatomy which was taken from the radiograph of patient. A

dynamic Finite element analysis was done for different activities like slow walk, normal walk, fast walk, up stair, down stair, standing up, standing down, standing on 2-1-2 legs, knee bend, and, jogging by considering average person weight was a 100 kg. The virtual study marked minor stresses in head and neck section of the customized hip prosthesis stems than the standard implant. [16] As shown in Fig.10

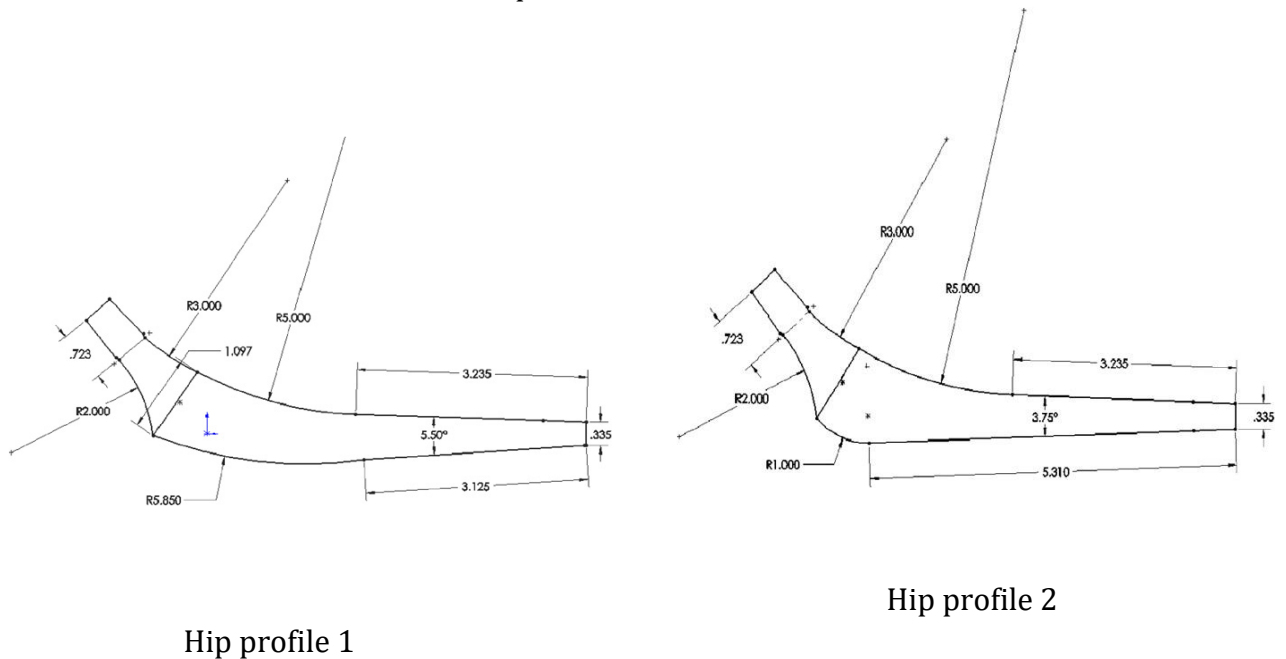
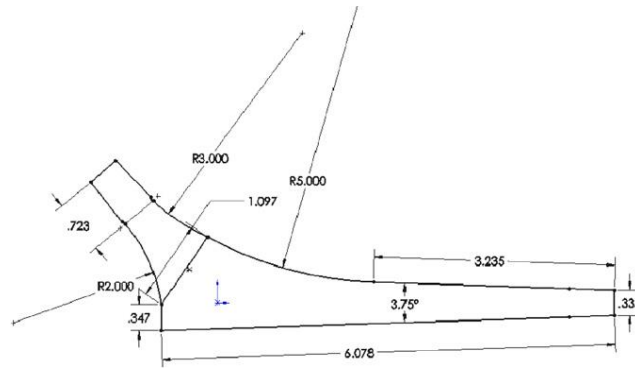
Fig.11. Different Hip Profiles

Three hip profiles shown in Fig.11 were disclosed by Anthony L. Sabatini et. Al, Hip profile 1 having radius on proximal end at lateral side along with having straight stem. In hip profile 2 medio-lateral angle of stem extend also radius and arc length of profile amplify. Lastly, in profile 3 corner shoulder provide against radius on lateral side.

To developed twelve hip stem design these three hip profiles combined with the four cross-sections namely circular, elliptical, oval, and trapezoidal along with analyzed in COSMOS Works for CoCrMo, Ti6Al4V, and SS 316L material, by applying 3000N load perpendicular to the neck of hip implant (see Fig12). After analysis it was observed that in case of trapezoidal cross section of stem profile distribute stress evenly on the medial side, but not evenly allocate from the medial to lateral side. But design having circular and elliptical cross section didn't emerge low stress value. The Ti6Al4V show inferior stresses than the CoCrMo and SS316L [27]

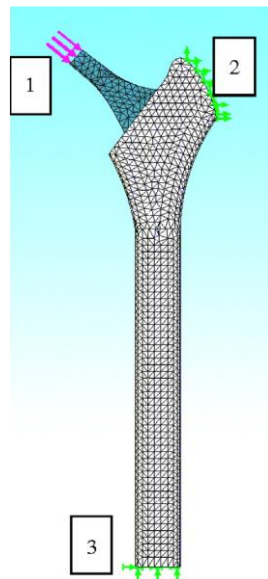
Fig.12. Mesh of femur, pt. 1 show 3000N applied load, pt. 2 & 3 show fixed portion of femur
